VIDEO PRESENTATIONS

Retrograde Paravalvular Leak Closure Using the Arteriovenous Loop Technique: A Case Report

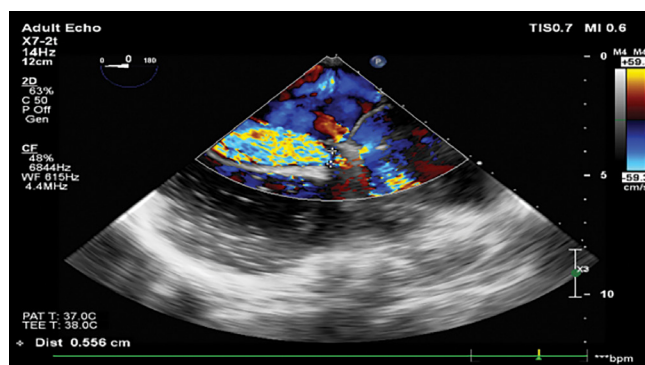
Figure 1. Transesophageal echocardiography image demonstrating a severe paravalvular leak localized between the 1 and 3 o'clock positions around the metallic mitral prosthesis

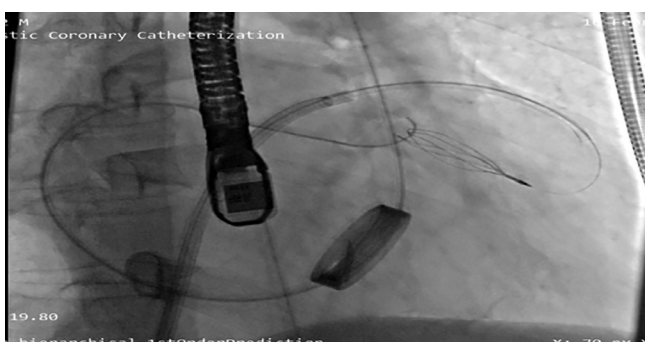
Figure 2. Capturing the noodle wire with snare

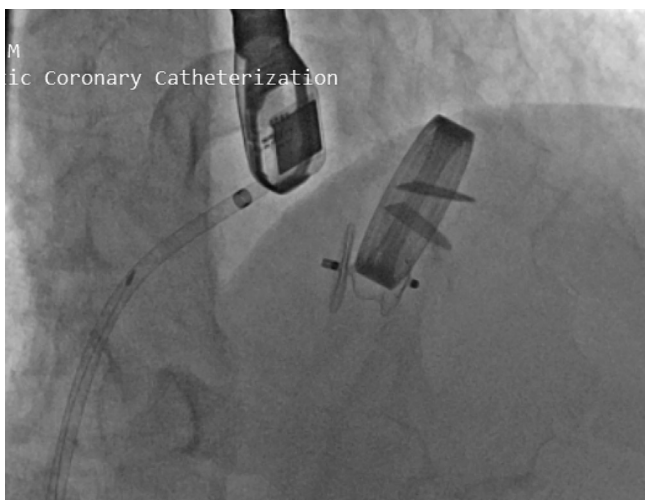
Figure 3. Post-procedural fluoroscopic evaluation

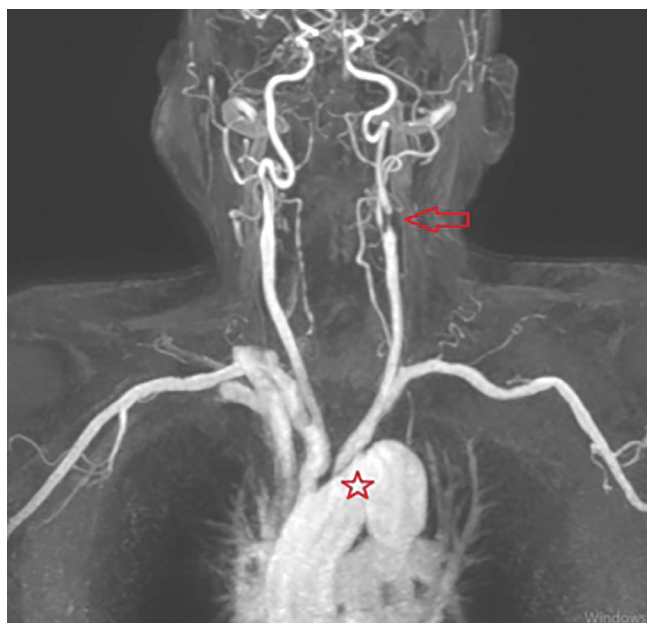
Figure 1. MR angiography demonstrated a type III aortic arch and a 99% ulcerated plaque in the left ICA

Case Report: An 87-year-old male patient, who had suffered an ischemic stroke ten days earlier, demonstrated diffusion restriction in the left hemisphere on cranial MRI (Figure 1). Carotid Doppler ultrasound revealed a soft plaque in the proximal segment of the left internal carotid artery (ICA), causing 90-95% luminal stenosis over a 3 cm segment. MR angiography demonstrated a type III aortic arch and a 99% ulcerated plaque in the left ICA (Figure 2). Cannulation of the left CCA was attempted using a 5-F right catheter, 6-F AL1 and AL2 catheters, 5-F Sim 1 and Sim 2 catheters, and 0.035- and 0.038-inch guidewires. However, due to the steep angulation of the left CCA origin from the aortic arch, all attempts were unsuccessful. Subsequently, a Sim 2 catheter was advanced telescopically through a 7-F right guiding catheter, allowing cannulation of the proximal left CCA. Through the Sim 2 catheter, a 0.014-inch floppy wire (TaHa Biomedical) was advanced into the distal superficial temporal artery, a branch of the external carotid artery (ECA). Over this wire, a 3.0×20 mm balloon was inflated at 12 atm to provide anchoring support. With distal balloon anchoring, the 7-F right guiding catheter (TaHa Biomedical) was advanced over the Sim 2 catheter into the left CCA. A 5.5 mm SpiderFX™ (Medtronic) distal embolic protection device was deployed in the left distal ICA. Predilatation was performed with a 3.0×20 mm Ryurei™ (Terumo Medical Corporation) coronary balloon at 10 atm. An 8×25 mm Roadsaver stent (Terumo Medical Corporation) was then successfully implanted, followed by postdilatation with a 5.0×12 mm Mozec™ (Medical Corporation) coronary balloon at 12 atm. Full luminal expansion was achieved. The filter was retrieved, and the procedure was completed without complications.

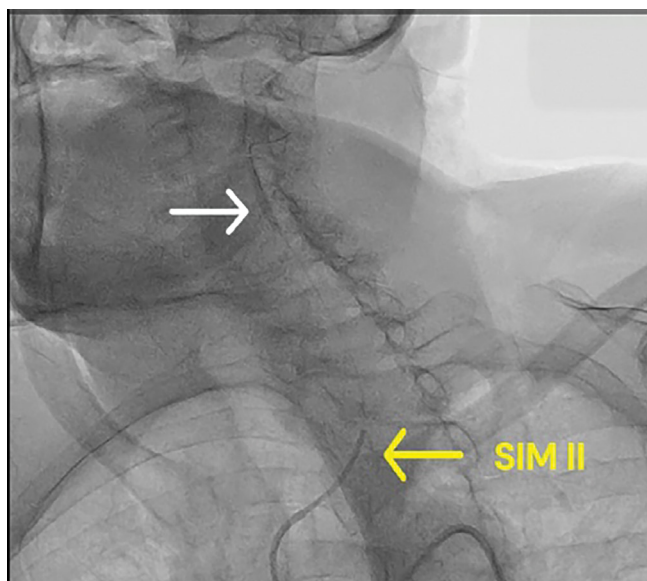
Figure 2. Over this wire, a 3.0×20 mm balloon was inflated at 12 atm to provide anchoring support

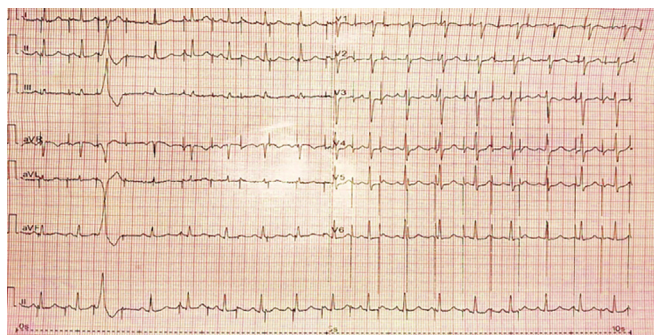
Figure 1. Electrocardiogram demonstrating prominent pacing spikes without subsequent ventricular depolarization, consistent with loss of pacing capture

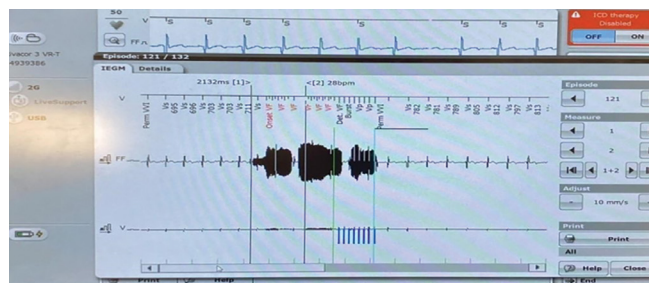
Figure 2. Device interrogation showing reduced sensing amplitude, increased lead impedance, elevated pacing thresholds, and high-frequency electrical noise associated with inappropriate ICD shocks

Case Report: A 58-year-old female patient presented to the emergency department after receiving inappropriate ICD shocks. Her medical history was significant for hypertension, diabetes mellitus, and heart failure. Coronary angiography performed in 2024 revealed normal coronary arteries, and a single-chamber VVI-ICD was implanted in 2025 for primary prevention. On admission, her vital signs were stable and physical examination was unremarkable. Electrocardiography demonstrated prominent pacemaker spikes without subsequent ventricular depolarization, consistent with loss of pacing capture (Figure 1). Device interrogation revealed reduced sensing amplitude, loss of pacing capture, increased lead impedance, elevated pacing thresholds, high-frequency electrical noise, and inappropriate ICD shocks, all of which suggested a mechanical lead complication (Figure 2). Transthoracic echocardiography showed a left ventricular ejection fraction of 45%, with

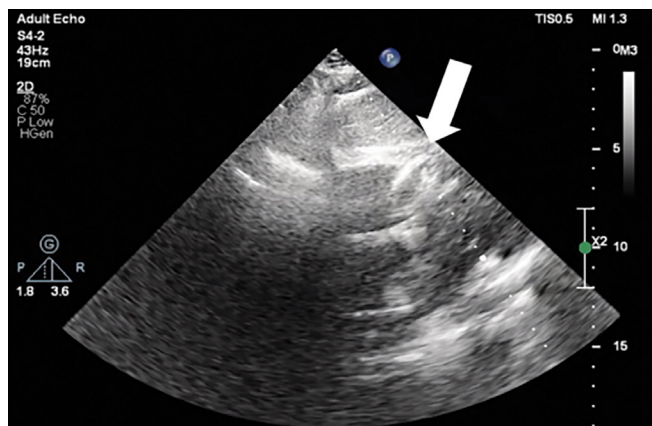
Figure 3. Transthoracic echocardiography (subcostal view) demonstrating a right ventricular lead position suspicious for myocardial perforation

segmental hypokinesia and mild valvular regurgitation. No pericardial effusion was detected. In addition, subcostal imaging demonstrated a right ventricular lead appearance consistent with perforation (Figure 3). Due to suspected abnormal lead positioning on chest radiography, cardiac computed tomography was performed. The CT scan demonstrated that the ICD lead had perforated the right ventricular free wall, traversed the pericardial space, and extended into an extracardiac location (Figure 4). A multidisciplinary heart team evaluated the patient, and surgical intervention was selected due to full-thickness perforation with extracardiac lead migration. Intraoperatively, the lead and device were removed, and the right ventricular free wall defect was repaired primarily. The postoperative course was uneventful, and the patient was discharged in stable condition.

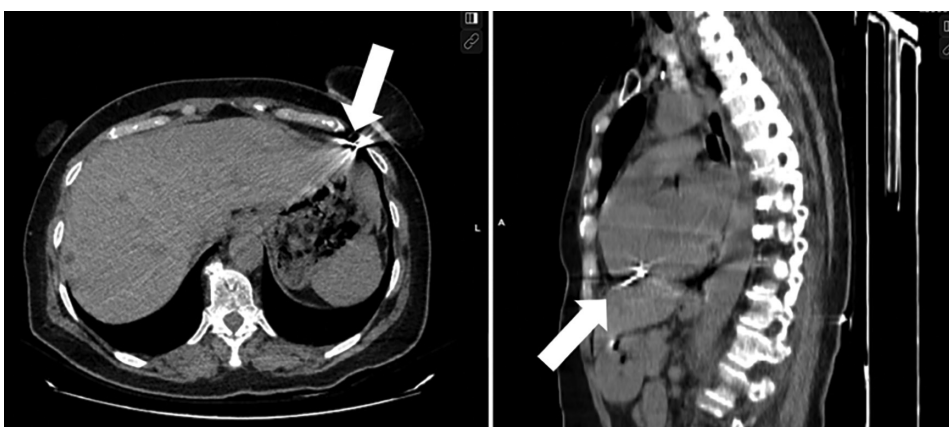
Figure 4. Cardiac computed tomography revealing perforation of the right ventricular free wall by the ICD lead, extending through the pericardial space into an extracardiac location

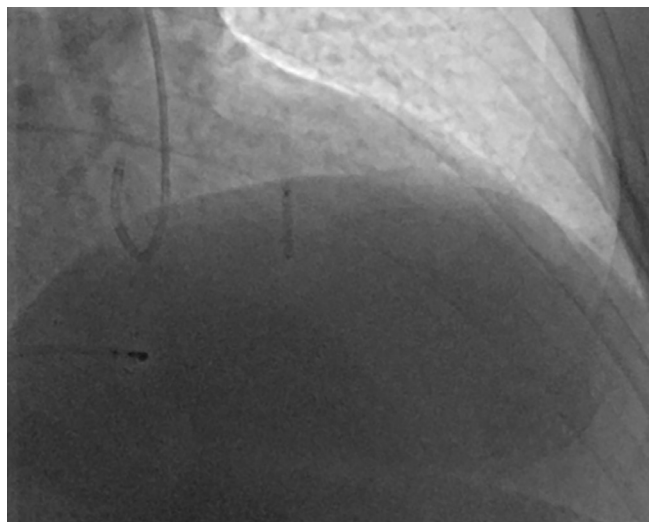
Figure 1. Septal ablation procedure

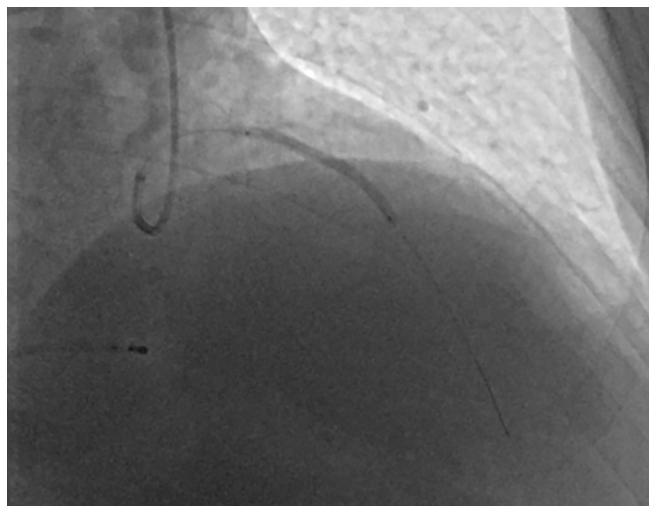
Figure 2. LAD PCI procedure
